DEPARTMENT OF TRANSPORTATION**DIVISION OF ENGINEERING SERVICES**

Quality Assurance and Source Inspection

Contract #: 04-0120F4Cty: SF/ALA Rte: 80 PM: 13.2/13.9File #: 1.28**WELDING INSPECTION REPORT****Resident Engineer:**Siegenthaler, Peter**Address:** 333 Burma Road**City:** Oakland, CA 94607**Report No:** WIR-024651**Date Inspected:** 24-Jun-2011**Project Name:** SAS Superstructure**OSM Arrival Time:** 700**Prime Contractor:** American Bridge/Fluor Enterprises, a JV**OSM Departure Time:** 1730**Contractor:** American Bridge/Fluor Enterprises, a JV**Location:** Job Site**CWI Name:** Listed below**CWI Present:** Yes No**Inspected CWI report:** Yes No N/A**Rod Oven in Use:** Yes No N/A**Electrode to specification:** Yes No N/A**Weld Procedures Followed:** Yes No N/A**Qualified Welders:** Yes No N/A**Verified Joint Fit-up:** Yes No N/A**Approved Drawings:** Yes No N/A**Approved WPS:** Yes No N/A**Delayed / Cancelled:** Yes No N/A**Bridge No:** 34-0006**Component:** S.A.S. components**Summary of Items Observed:**

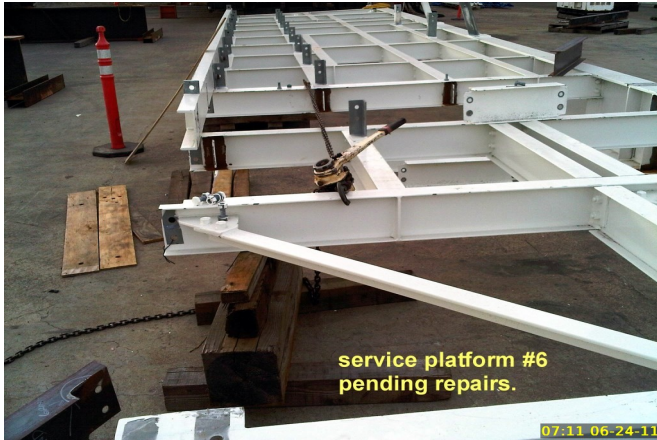
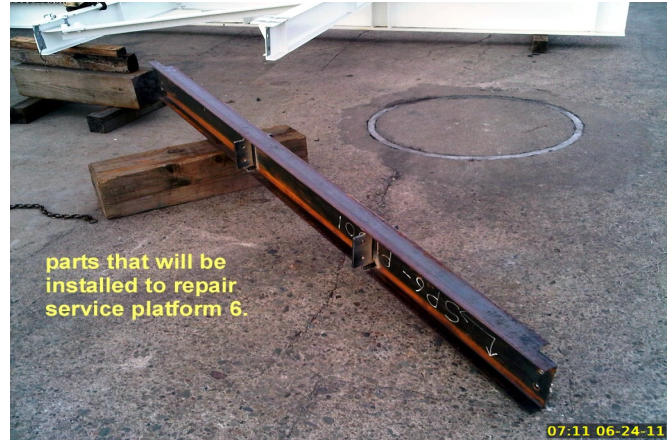
1) The QAI went to ABF facilities at Pier 7 to observe repair welding of service platform #5 and service platform #6. The QAI met with the Quality Control Inspector (QCI) Mike Johnson and made general observations of the service platforms as they were presented. The QAI and the QCI noted that the primary members for repair have been welded, the QCI informed the QAI that this welding was performed on 6.22.2011. The QAI noted that there appears to be 2 unwelded connection pieces for service platform #5. The QAI asked the QCI when this welding would be done. The QAI was informed that the primary members needed to be re-fit and bolted before the remaining pieces could be fit-in and welded. The QCI remarked that he was not aware of when this work would be performed. See the attached photos.

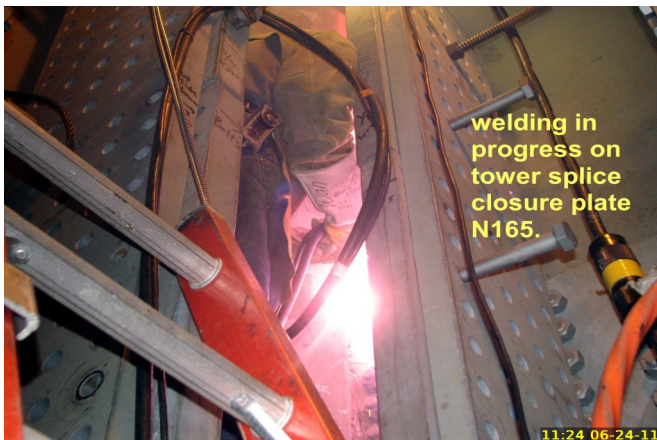
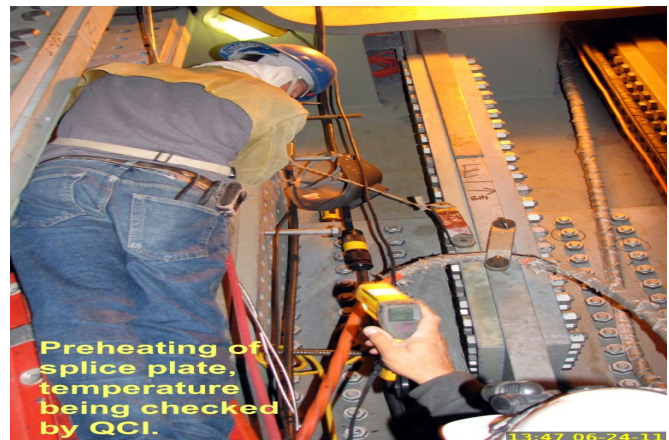
2) The QAI observed ABF personnel welding field splice closure plates inside the North tower shaft at field splice #3. The QAI observed Xiao Jian Wan, ID 9677, at the North upper plate (weld N165) and Salvador Sandoval, ID 2202, at the North-East upper plate (weld NE165). The QAI noted that both welders are making vertical fillet welds (3F) using self shielded flux cored arc welding (FCAW-S) with 1.8mm diameter E71T-8-H16 electrode (NR-232). The QAI observed that QCI Steve Jensen is monitoring this welding. The QAI was informed that

welding procedure specification ABF-WPS-D15-F2200-3 is being used for this welding. The QAI randomly measured the preheat, interpass temperature and welding parameters, with the exception of travel speed, and noted that they appeared to be conforming to the WPS requirements. The QAI noted that this welding was in progress at the end of the shift. See the attached photos.
